CARD READ SENSOR CALIBRATION INSTRUCTIONS

MODEL ATT 310

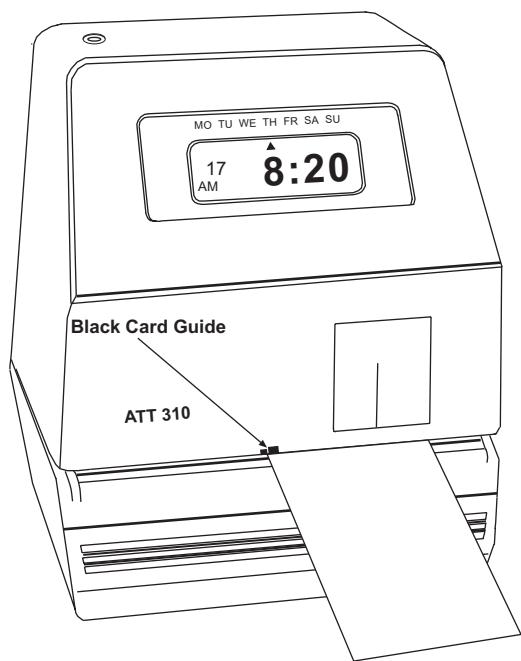
12)

- 8) Next, turn off all 8 switches on DIP SW2 and turn on all 8 switches on DIP SW1.
- 9) Insert the time card so that the blank area on the right edge of the card is facing down and under the black card guide. If the unit reads correctly, it will beep twice. If not, it will beep once. (This step calibrates the ATT310 for the blank area of the card) Once the unit has accepted the blank area of the card, **PRESS THE RESET SWITCH ONCE**.
